M8 Motorway slip road repaired and protected for the long term

SAFETRACK® Inlaid Road Repair prevents water ingress

Project	M8 Motorway Slip Road
Client	Transport Scotland
Contractor	LMS Highways
GCP Solutions	SAFETRACK® Inlaid Road Repair System

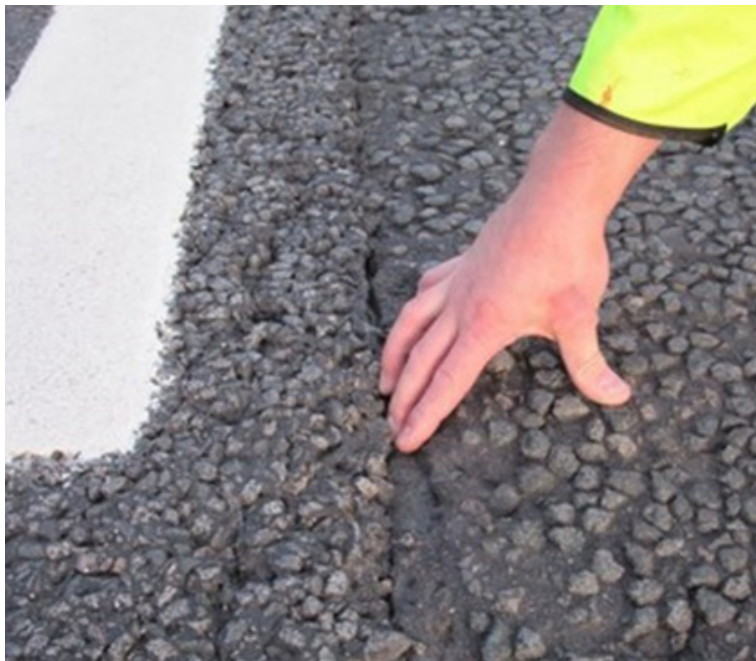
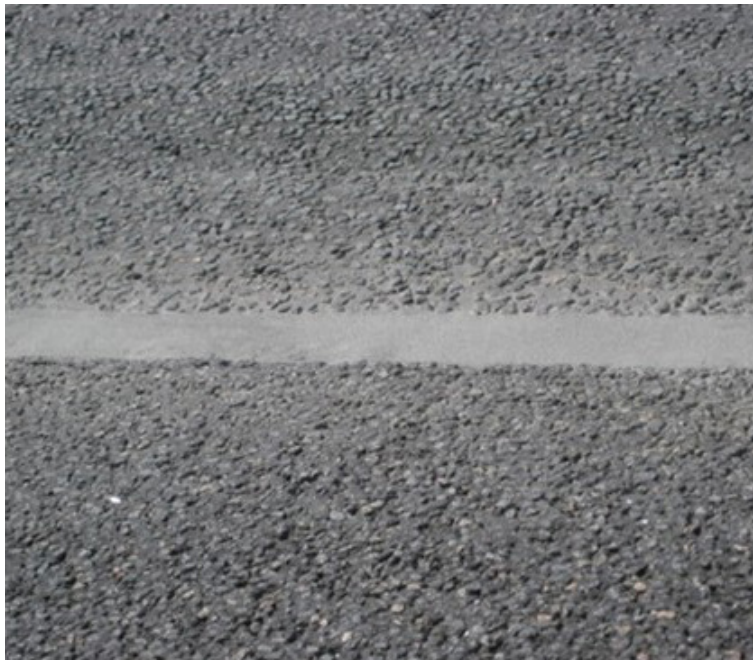
The fretted joints of the M8 needed repairing and sealing to prevent water ingress and further damage to the otherwise sound asphalt. The repair also needed to be strong enough to cope with high volume heavy goods vehicle traffic and the additional loads created by acceleration/declaration and transverse loading across the joint during lane changes.

The client selected the HAPAS-approved SAFETRACK[®] Inlaid Road Repair system, developed by Stirling Lloyd (now GCP Applied Technologies). A micro milling technique was also developed to reduce the amount of asphalt milled from the surface prior to inlaying the repair system. Based on unique ESSELAC[®] technology, the SAFETRACK[®] repair systems includes a unique resin that enables a thinner recessed repair to be achieved than would be possible with a traditional asphalt-based material. Less milling and less materials applied increases the speed of application and reduces cost and disruption.

The system's rapid cure meant that the road could be returned to full traffic load in as little as half an hour after installation, since there was no residual heat to be lost from the system. The system enabled more than 200 linear meters of fretted joint to be repaired per hour.
